JIG Learning From Incidents (LFIs) Toolbox Meeting Pack Pack 19 - November 2016

Learning From Incidents

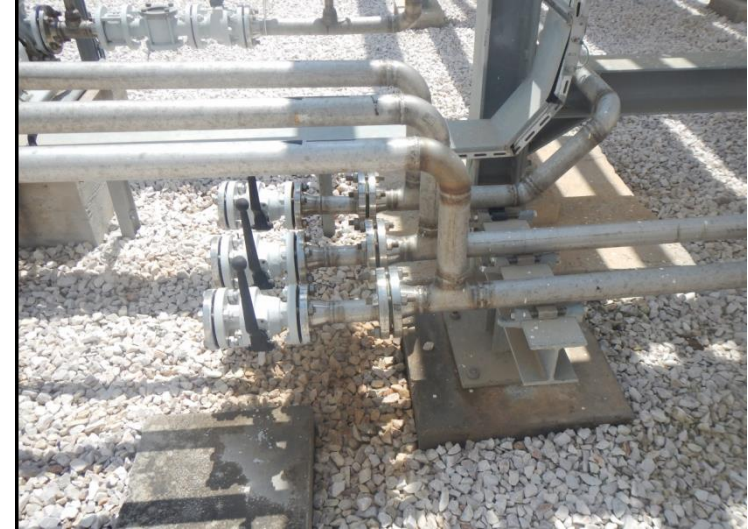
2016-14

Spill due to flange gasket failure

A small spill was observed while an Operator was carrying out a periodic safety inspection within the bunded areas of the airport depot fuel farm. He realised that the colour of the gravel under the 2" flanges had changed. On close inspection he observed that fuel droplets were leaking from one of the 3 flanges (see photo) due to a failed gasket. The said pipe was a part of the bottom drain line from one of the storage tanks that was connected to the tanks' centralised sampling system. He depressurised the fuel pipe and stopped the leak.

- Following incident investigation, it was observed that the thermal relief valve (TRV) was never designed/installed for the tank drain lines although installed elsewhere. It was decided to install a TRV and modify the tanks' drain lines so that all of them can be thermal released by the same TRV. P & I D drawings revised.

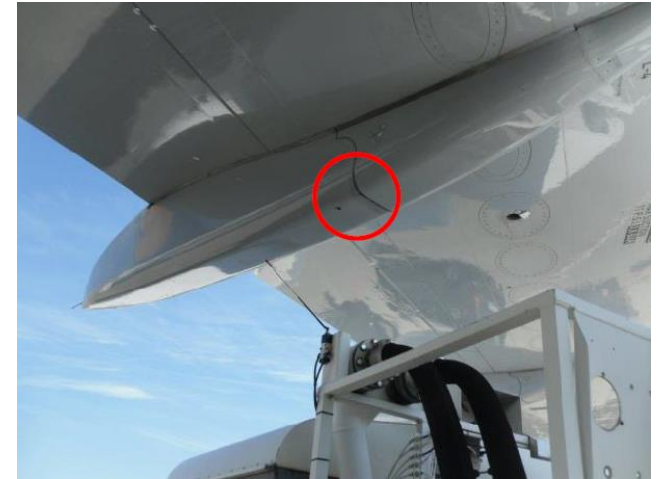
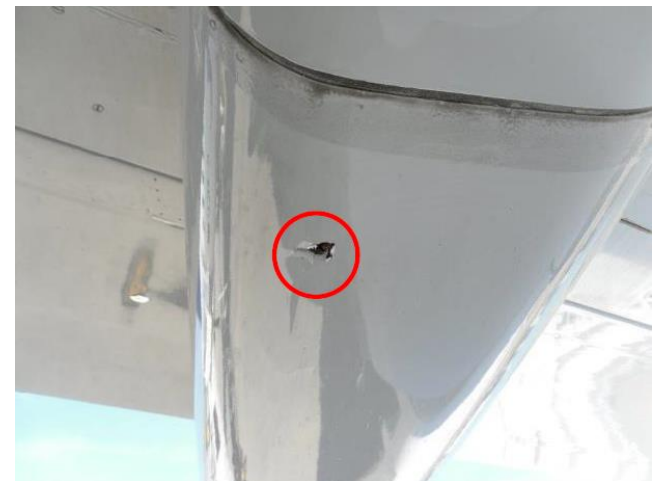
2016-16

AC Damage while raising elevating platform (AC Damage)

An Operator carried out a deck hose fuelling operation with a refuelling truck. In order to connect the deck hose, he raised the platform. When at the correct height, the platform control device did not stop the upward movement. The Operator stopped the upward movement by using the emergency stop but the wand sensor made contact with the wing flap trap fairing and punctured a small hole in it.

- The design of the pneumatic control safety circuit was found to be unsuitable. The wand (high limiter) sensor, the emergency stop and the control device for the lift platform are connected in series via a line to the compressed air tank. If the wand sensor reacts and the manual device is stopped by the Operator at the same time, the compressed air supply does not release quickly enough to stop the platform movement immediately.

Pneumatic control circuit has been modified so that the air line to the emergency stop and wand device is separate from the airline to control the platform lift. All vehicles with platforms have been checked, modified where necessary and stop devices tested.

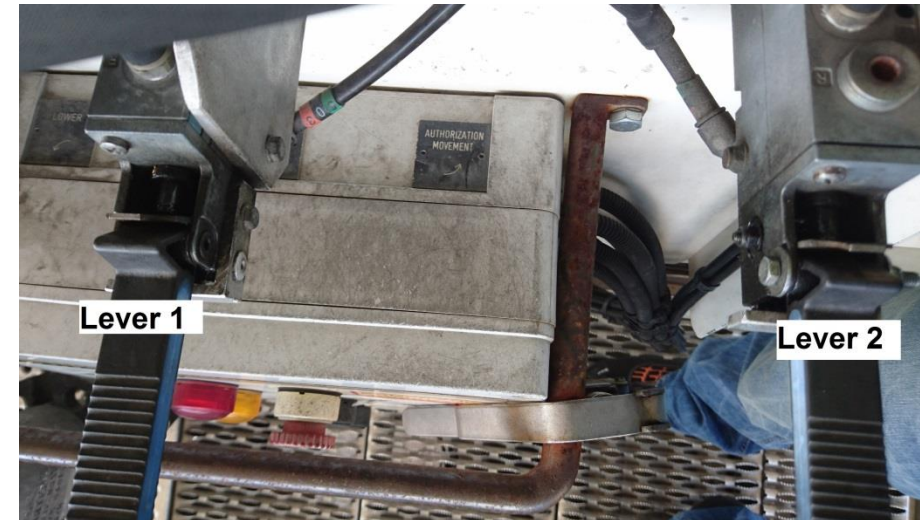
LFI 2016-17

Spill & AC damage while raising elevating platform

After completing an Airbus 330 fuelling the operator raised the elevating platform to access the fuelling couplings for disconnection. While raising the platform one of the fuelling hoses became trapped between the two (raise and lower) platform control levers. The hose pushed against the levers resulting in further unintentional raising of the platform. Once the wing wand touched the aircraft the movement was stopped. The bending force created on the hose by the handrail resulted in a breakaway at the predetermined points of the aircraft adaptor. Around 25 litres of Jet A-1 was spilled from the hose onto the apron and an underwing scratch was identified as a result of the incident. The aircraft was able to depart as scheduled.

- Incorrect fueller position under aircraft – platform not positioned under fuelling connections resulting in bending of the hose over the handrail.
- Incorrectly positioned elevating platform control levers – The risk of a stuck hose was not considered while installing the levers - a protection bar to avoid unintended activation is needed.
- Inefficient Wing Wand – The emergency stop preventing the elevating platform to be too close to the wing was activated when the platform was too high, resulting in a bending stress of the hose and break away.

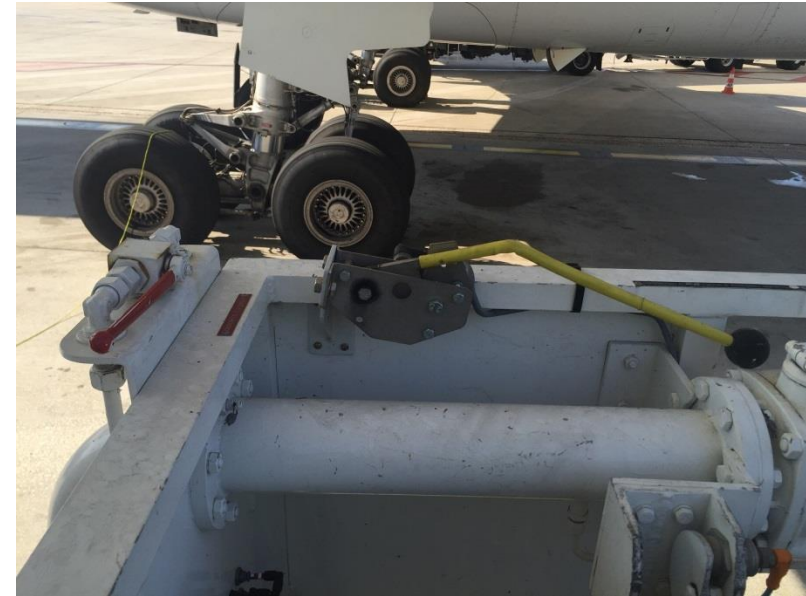
LFI 2016-18

Aircraft damage while raising elevating platform

In preparation of an Airbus 340 refuelling the operator raised the elevating platform to access the aircraft couplings. When the lever was released the elevating platform did not stop. The operator tried several times without result. Also the engaged wing wand did not stop the platform and the operator had to use the emergency button. By the time the platform stopped it had scratched the aircraft. Aircraft was delayed.

- A faulty hydraulic power case was identified - corrosion due to adverse weather condition
- The control lever and the wing wand switch are not independent from each other
- Location of the emergency stop button (ESB) was not in near area of where the operator is positioned when raising the platform, this resulted in delayed activation of the ESB.
- After the operator found the control not functioning correctly he re-tried several times instead of using the ESB directly without losing time on the faulty control

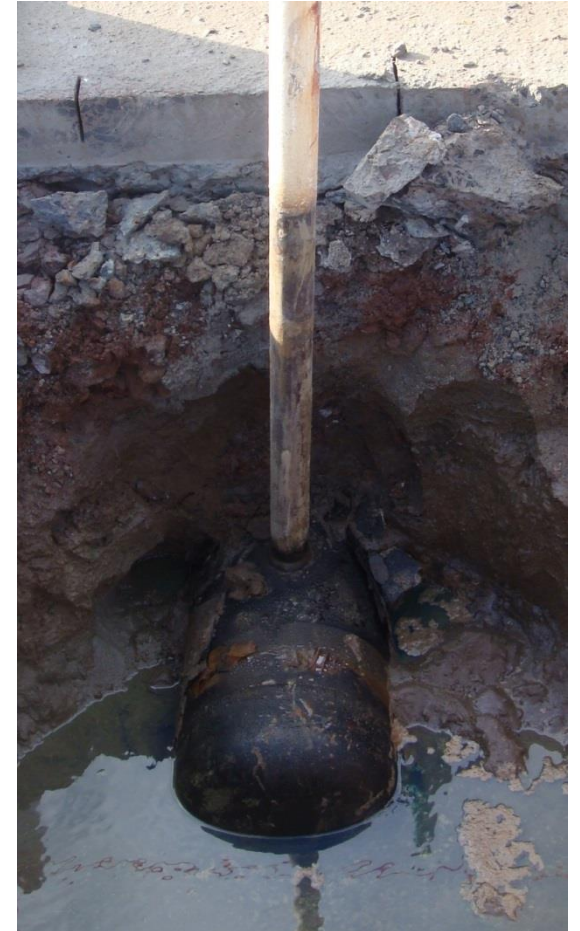
LFI 2016-19

Spill during pipeline pressure testing

A periodic pressure test of underground pipework was initiated to confirm pipework integrity. The test procedure is to observe the 120 psi test pressure for 4 hours. After 2 hours a sudden loss of pressure was identified. No visual indication of leakage was found. After checking the equipment it was concluded that an underground leakage could have occurred. Possible solutions on how to deal with the incident were discussed. Pipework isolations to further narrow the location of the leak were installed. The remaining fuel was removed from the underground pipework.

- Cause of pipe failure not known at this stage
- Site was not prepared for this spill event– Emergency response was not defined
- Lack of contractor management around test methods used and emergency preparedness

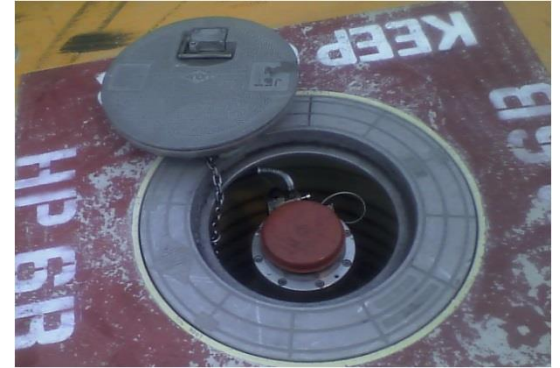
LFI 2016-20

Manual Handling Injury

An Operator was removing a composite hydrant pit lid, lost grip of the handle and trapped a finger in between the lid and the ground. This resulted in a fracture of the top of the finger. There was no evidence of other factors contributing to the incident such as fatigue, use of drugs or alcohol or external / personal circumstances. Appropriate first aid was provided very soon after the incident occurred that prevented further potential complications associated with swelling.

- The Operator adopted an incorrect manual handling technique and body position for the task. The free hand was positioned horizontally on the ground rather than positioned on the knee and the movement of the pit lid was across the body rather than to the right (lifting hand) side. Complacency may have set in on this regular task.
- There was no external visual indication of pit lid tether location, which can cause snagging when lifting the lid.

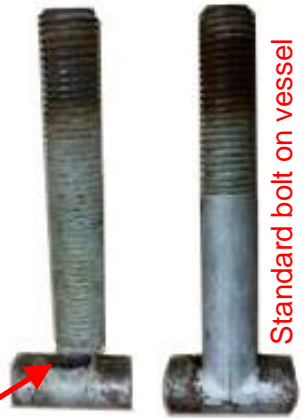
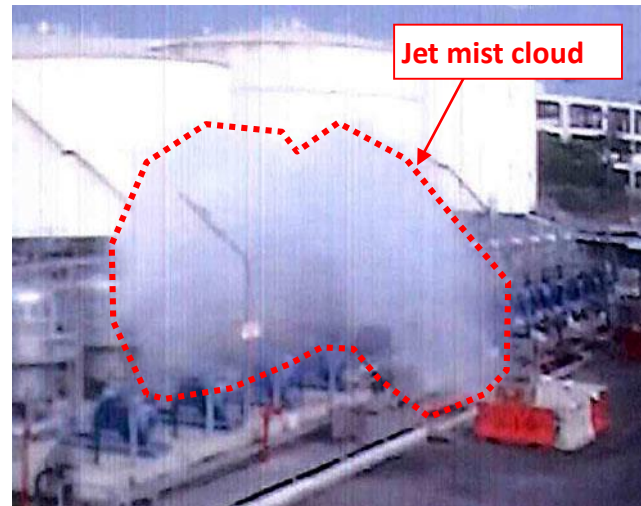
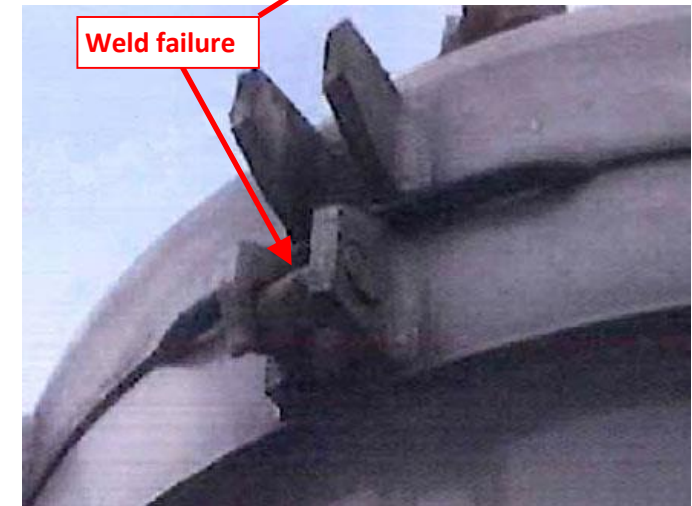
2016-21

FWS seal failure due to excessive surge pressure

A hydrant extension was being flushed into vehicles during commissioning and valves on a temporary manifold connected to the hydrant riser were closed too rapidly; this caused excessive surge pressures and resulted in a mist cloud and a 2000-3000 litre spill from one of the into-hydrant Filter Water Separator (FWS) dome seals – one of the lid bolts, which was different to the others, failed causing the dome seal to be dislodged. Another bolt became loose, but all the other bolts were in good condition.

- Valve closure times on the flushing manifold were not calculated to ensure that high surge pressures were not generated.
- The hoses to the vehicles were downstream of the manifold valves so they were unable to provide any surge pressure attenuation.
- The failed bolt, which was different to all the other bolts, sheared off at the weld between the threaded shaft and the head.

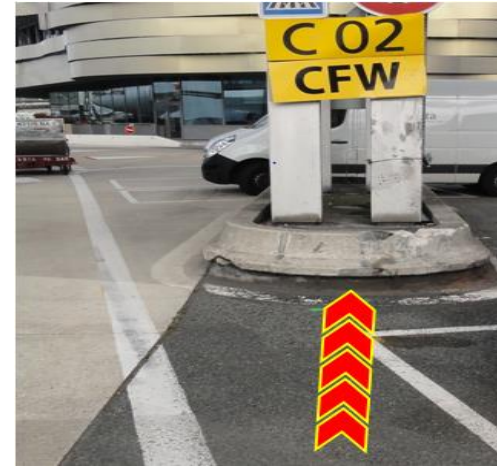
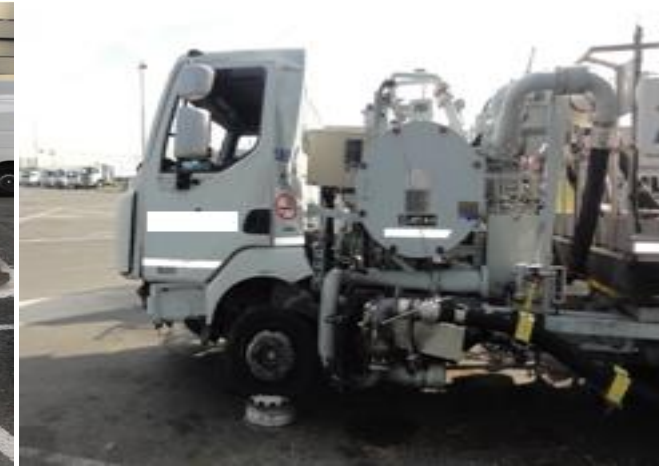
LFI 2016 - 23

Vehicle Incident

An Operator was on his way back from the apron after completing the second daily refuelling operation. The driver overran a stop sign and after travelling 200 meters hit a low concrete wall then a post of a building near a parking area. Fortunately the operator was wearing his seatbelt preventing him from a more severe injury although it did result in an LTI. The fuelling vehicle, severely damaged, could not be moved holding up the traffic.

- The Operator said he had no recollection of the incident.
- Sleep could have been a cause as there were no visible braking marks on the road. However he had just come off a rest period.
