JIG Learning From Incidents (LFIs) Toolbox Meeting Pack Pack 19 - November 2016

Learning From Incidents

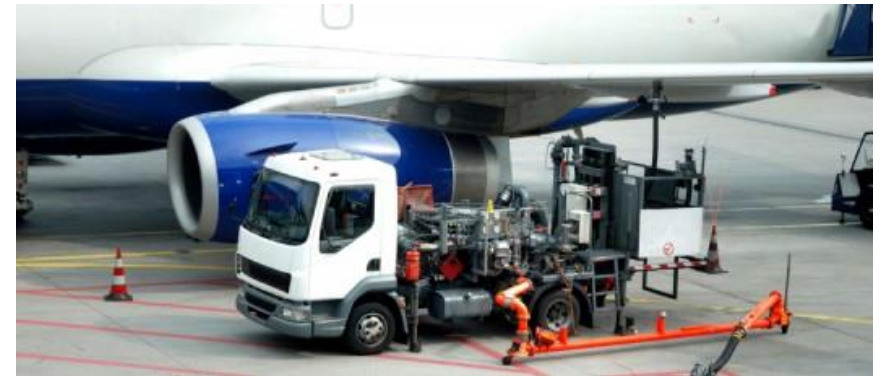
An operator received a fuel request from a ramp agent for a specified quantity of fuel for a flight that had just arrived and was due to depart soon after. The flight was due a crew change but the replacement pilot's inbound flight was delayed. In order to avoid delaying the outbound flight, the ramp agent and replacement first officer oversaw the fuelling of the aircraft in preparation for departure. As the operator prepared to fuel, the pilot being replaced approached and asked for 'full wings' without checking the flight plan. The operator queried the change request with the ramp agent but the pilot repeatedly intervened insisting on 'full wings'. The operator stayed calm and applied the agreed procedure which was to accept the request received from the ramp agent. When the replacement pilot eventually arrived he confirmed that the fuel request received from the ramp agent was the required volume for the flight plan and thanked the operator for his actions.

- The pilot being replaced did not follow agreed procedures
